# Survey of Mulberry B

By Chris Howlett

**B**etween September 24 and October 8 an international team, led by the UK Hydrographic Office, conducted a detailed bathymetric survey of Mulberry B located off shore near Arromanches in Normandy, France.

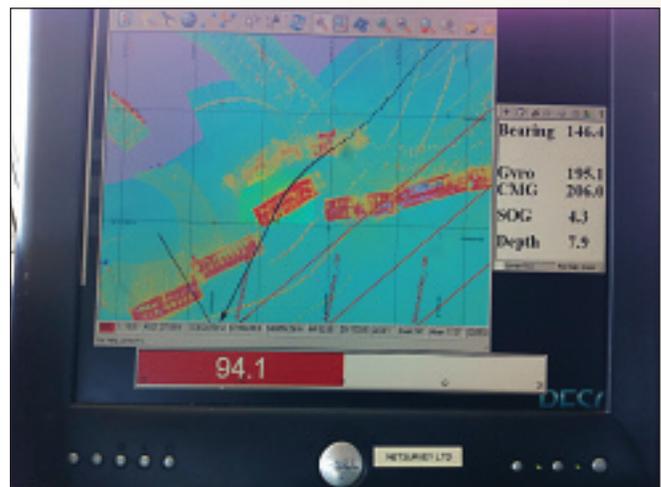
An image of the real-time navigation display. Colour coding is by depth (red is shallow, blue is deep) and the submerged remains of several Phoenix caissons are clearly visible (red).

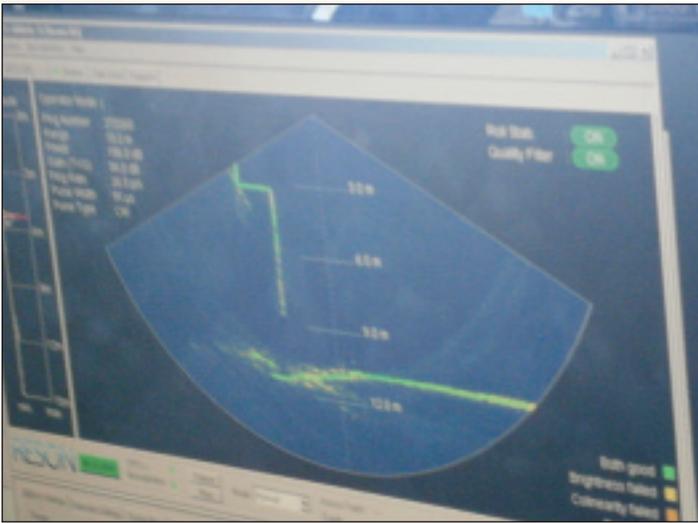
The real-time sonar display showing what is being detected by the multi beam. Clearly shown is the vertical wall of a nearby caisson to port with a flat and featureless sea floor below.

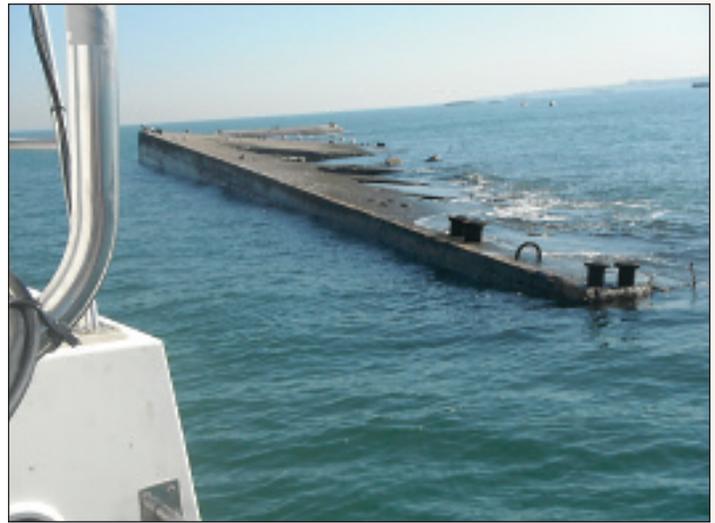
Navigating close to nearly submerged caissons at low water. These caissons are the large AX type, which are 200 feet long, 60 feet wide and 60 feet high. The boat is about 20 feet off the caisson. Only the extremely calm conditions allowed the boat to be this close.

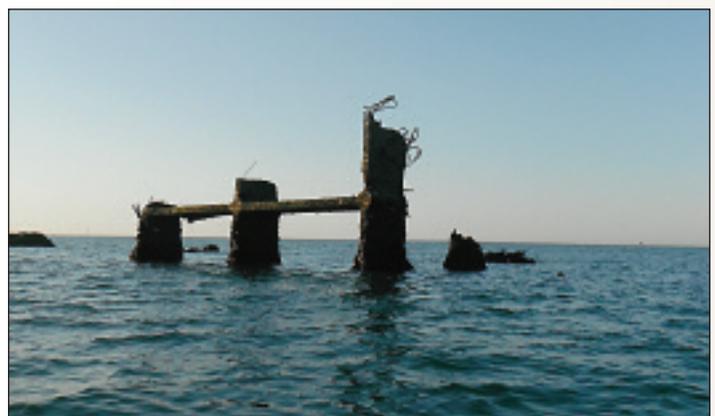
Some of the dangers that remained submerged at high tide but became exposed at low water. The vertical concrete structures and extruding rebar constituted a very real danger for the survey boat.

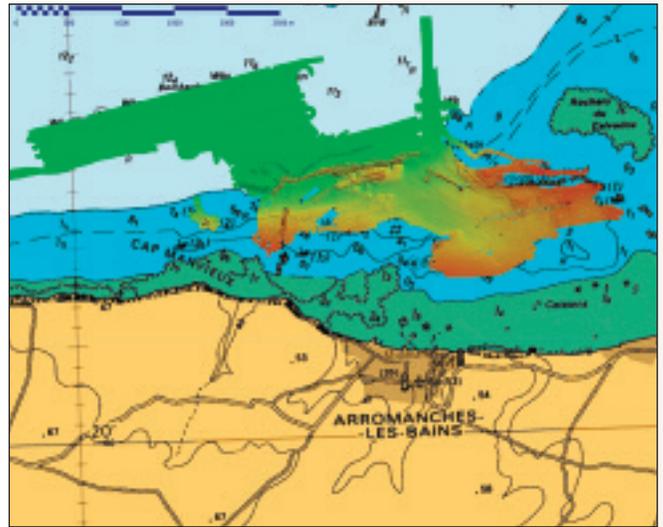
Coverage diagram showing extent of the multi beam survey overlaid on a UKHO chart. The colours denote depth (red is shallow, green is deep) and the various caissons are clearly visible. This is raw data and still has much noise to be removed but shows the area covered. The large green section to the top left is the area within which the wrecks of the Bombardons lie.
